HOUSATONIC RIVER BASIN  
HINSDALE, MASSACHUSETTS

PLUNKETT RESERVOIR DAM  
MA 00226

PHASE I INSPECTION REPORT  
NATIONAL DAM INSPECTION PROGRAM

AUGUST 1981

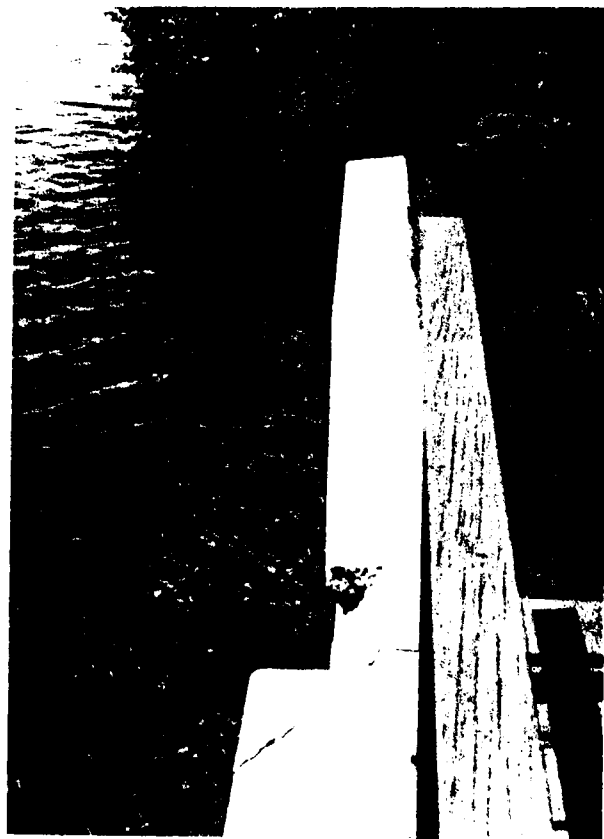
The left spillway wingwall at the left abutment has been displaced out into the reservoir resulting in misalignment and cracking of the wall, as shown in photograph 12.

e. Failure of the left spillway wingwall could lead to failure of the left spillway training wall resulting in a breach through the left abutment.

PHOTO NO.12 - Wingwall on left  
side of spillway  
showing cracks in  
wall resulting  
from outward move-  
ment of wall.

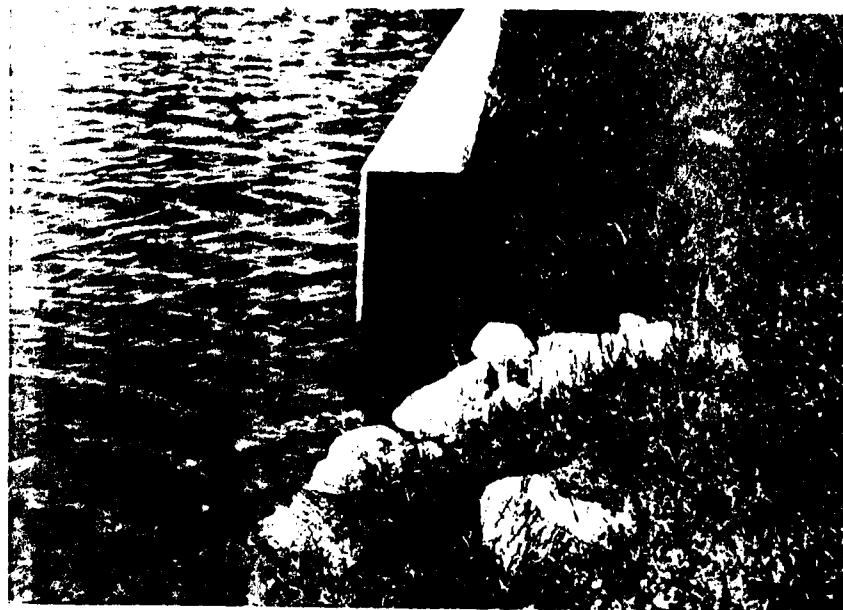
a. The upstream slope riprap is in poor condition and the upstream face is being eroded. This condition could eventually lead to instability of the upstream slope.

PHOTO NO.9 - Eroded area on upstream face at right end of spillway wingwall.

1. Repair of the riprap and existing sloughing on the upstream face of the dam.
2. The source of seepage found at the toe of the dam.

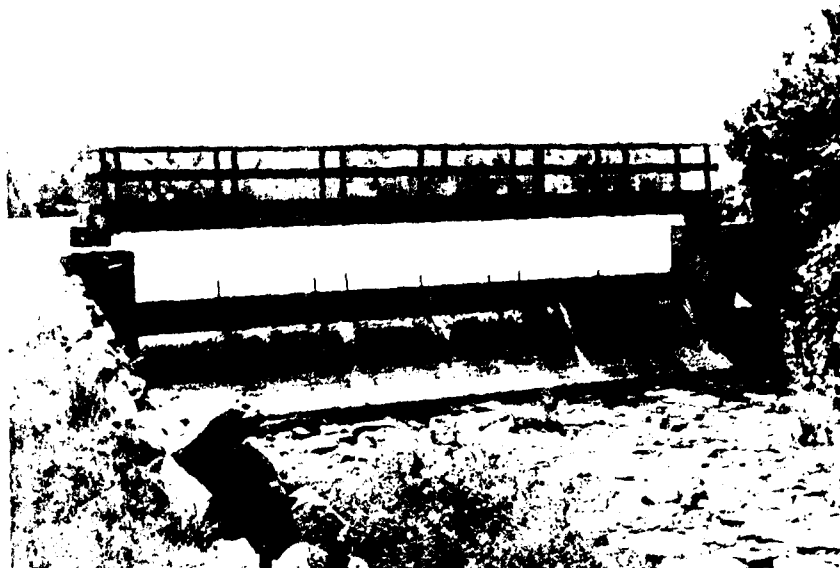
The spillway weir was in good condition. There were 14 inches of flashboard in place at the weir during the inspection. The pins and flashboards, shown in photograph 4 were observed to be in good condition. The spillway bridge was in good condition, however, it lacked lateral bracing and shook sideways easily.

PHOTO NO.7 - View of spillway weir and bridge.  
There are 14 inches of flashboards  
in place.

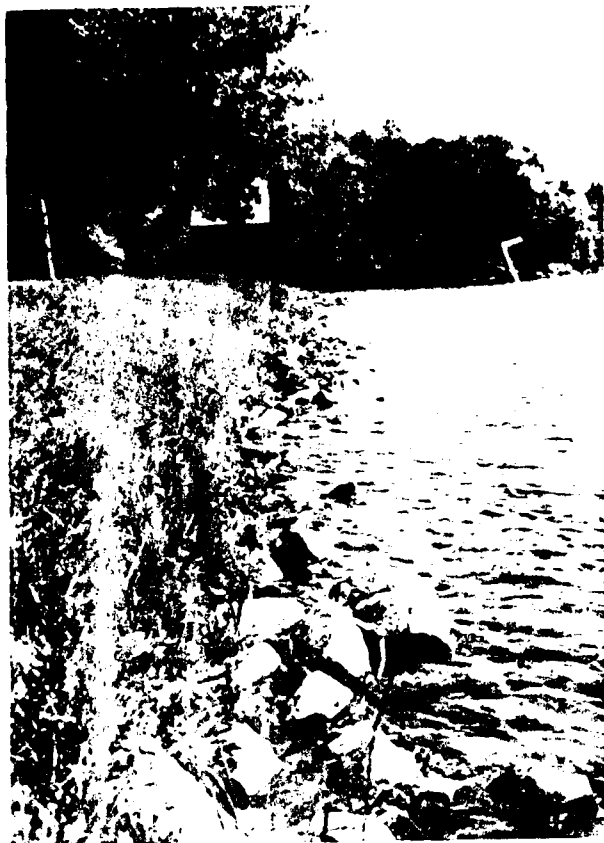
PHOTO NO.3 - Left half of up-  
stream face of  
dam from spillway.

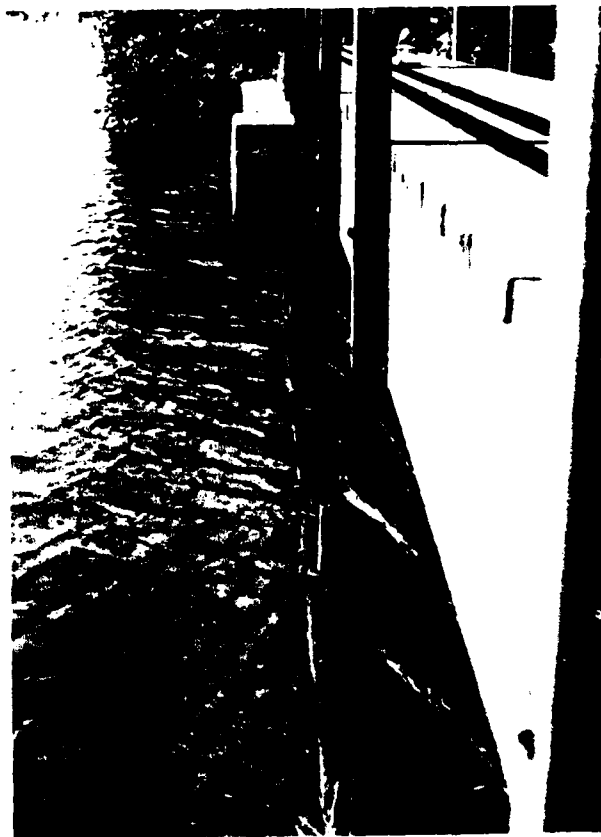
PHOTO NO.4 - Spillway flash-  
board assembly  
viewed from right  
side of spillway.
